# Slutrapport

Hållbar hantering av befintliga tegelfasader: Identifiering av kunskapsluckor och framtida behov inom rivning och cirkulära metoder

Sustainable management of existing brick masonry: Identifying knowledge gaps and future needs in demolition and circular practices

Lunds universitet

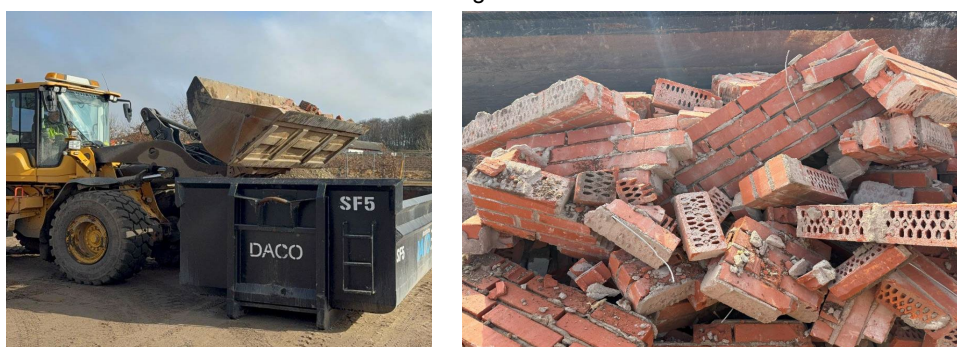
Figure 3. Reclaimed bricks collected after demolition are to be delivered to Brukspecialisten

Site visits were conducted at demolition projects involving brick masonry, including a school building scheduled for demolition (as shown in Figure 2 and Figure 3). These visits enabled direct observation of demolition methods, handling practices, and initial sorting of masonry materials. The field observations confirmed that cement-based mortars significantly reduced separability, while controlled demolition and careful handling increased the proportion of bricks suitable for reuse or repurposing.

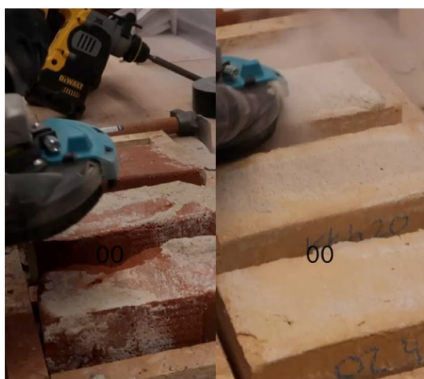
Power hammer

Paoloni cleaning machine

Angle grinder

Wet cutting

Figure 5. Examples of brick cleaning methods assessed within the project include power hammer, Paoloni oscillating chisel machine, angle grinding, and sawcutting

Once bricks are separated, they must be cleaned to remove residual mortar and prepare them for reuse. The effectiveness of cleaning depends on the mechanical force applied, the chosen technique, and the characteristics of both brick and mortar. Within the project, commonly available cleaning methods were qualitatively assessed as shown in Figure 5. Manual and semi-mechanised techniques, such as chiselling and grinding, can remove mortar efficiently when brick strength is sufficient and bond strength is moderate, but they carry risks of brick damage, dust generation, and operator exposure. Wet cutting consistently produces clean, flat surfaces and is applicable across mortar types, though it introduces moisture and may reduce brick dimensions, requiring additional drying and quality control.

Other methods, such as oscillating chisel machines, were found to be less effective for hydraulic mortars and may increase the risk of brick damage when bond strength is high. Raking and friction-based methods are primarily suitable for weak air-lime mortars and ineffective for modern cement-based systems. Overall, no single cleaning method is universally optimal; the choice must be adapted to mortar type, brick quality, scale of operation, energy demand, and safety considerations.

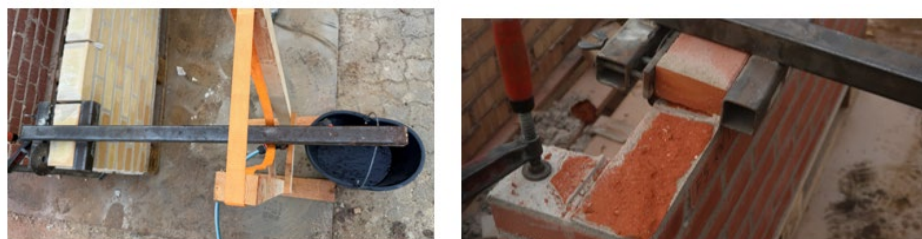
Figure 6. Test setup the so-called bond wrench to assess the bond strength between brick and mortar

For masonry built with yellow bricks (compressive strength approximately 35 MPa), air-lime mortar with 9% lime content exhibited the lowest bond strength, on the order of 0.05 MPa, combined with high variability. Despite this variability, separability was exceptionally high: all bricks remained intact after toppling, and more than half remained reusable after repeated handling. The low bond strength allowed cracks to localise in the mortar rather than propagating through the brick. In contrast, cement-lime mortars with higher cement content achieved substantially higher bond strengths, typically 0.48-0.61 MPa. These mortars showed markedly reduced separability, with fewer than one quarter of the bricks remaining intact after the full handling sequence. Figure 6 shows the test procedure used to assess bond strength in accordance with the EN 1052-5 bond wrench test [8]. Figure 7 shows the assessment of separability in masonry specimens, including the procedure for counting intact full bricks and half bricks as representative measures of reuse potential.

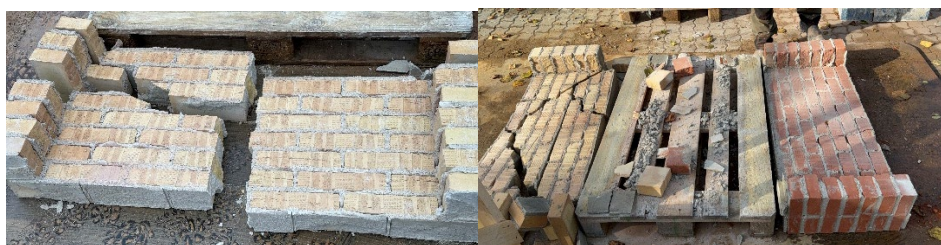
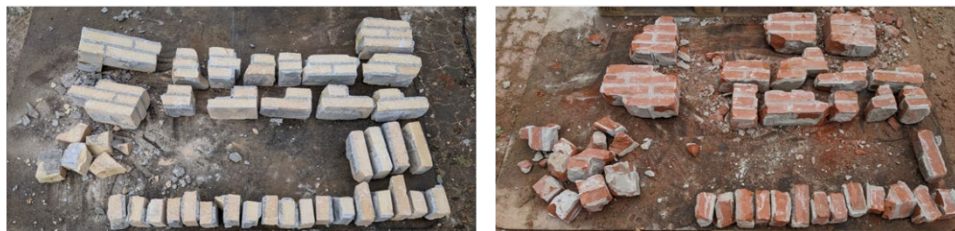
Figure 7. Different steps were taken to assess the separability, showcasing the demolition practice in reality – Number of full and half bricks salvaged after separation and demolition

For masonry built with red bricks (compressive strength approximately 18 MPa), the same overall trends were observed, but with consistently lower separability levels. The lower strength and more brittle behaviour of the red bricks made them more sensitive to impact and handling damage. Even when bonded with weak air-lime mortar, separability after repeated handling was substantially lower than for yellow bricks. Nevertheless, the air-lime mortar still performed best, achieving complete separation after toppling and retaining roughly one-third of the bricks after the full handling sequence. Cement–lime mortars again showed the poorest performance, with separability generally below 15% and, in several cases, close to zero.
